NASA/TM—2005-213473

The Implications of Handling Qualities in Civil Helicopter Accidents Involving Hover and Low Speed Flight

*Daniel C. Dugan and Kevin J. Delamer (CDR-USN)
National Rotorcraft Technology Center
Ames Research Center, Moffett Field, California*

November 2005

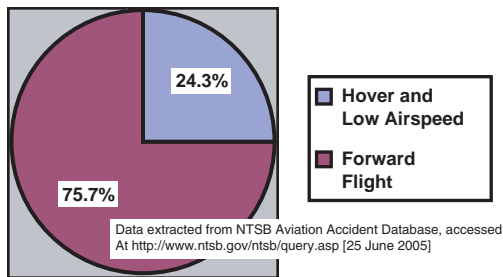
Figure 1. Hover and Low Airspeed Helicopter Mishaps 1993–2004 (as a Percentage of All Helicopter Mishaps).

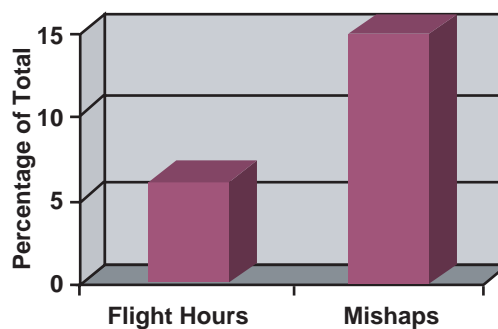
One particular type of operation that requires precise positioning by the pilot is the external load or sling load mission. It involves pick-up and placement of loads suspended beneath the helicopter. Often they are conducted in close proximity to obstacles and they require a high degree of precision and demand a high workload of the pilot. In this survey, 85 (or 15%) of the accidents occurred during external load operations, far exceeding the FAA determined helicopter utilization rate of 6% for this mission area (ref. 9), as shown in figure 2. Although most of these accidents could not be attributed to poor handling qualities, pilots involved in these operations need a stable platform for this precision task. Only six of the mishap aircraft in external load operations were equipped with an attitude command system. An attitude command system would have been a significant improvement for the

twenty-one helicopters involved that did have stability augmentation (rate command). Any augmentation would be a step in the right direction for the helicopters involved in the remaining accidents. It was sobering to calculate the toll from these external load accidents as a matter of information. There were 38 fatalities, 26 serious injuries, and 20 minor injuries. Twenty-six helicopters were destroyed and all of the others, with one exception, incurred substantial damage. It follows that this operation can be classified as hazardous regardless of handling qualities. Precise handling qualities are dictated by the tight tolerances required for these tasks. This highlights the benefits accrued by incorporating stability augmentation in helicopters performing this mission.

Figure 2. External Load Operations.

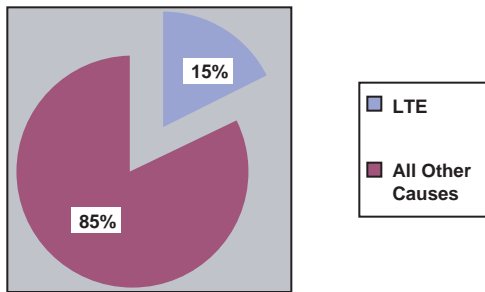
Figure 3. LTE Mishaps (as a Percentage of All Mishaps Studied).

For the accidents surveyed, 82 (or 15%) involved LTE (fig. 3). Recognizing the conditions that can lead to LTE is very important and the pilot's situational awareness is critical at all times. What direction is the wind with respect to the helicopter's heading? How much tail rotor control margin remains in terms of pedal applied? How much collective pitch can be applied before maximum available power is commanded and main rotor and tail rotor RPM start to decay? For the student or low time helicopter pilot, these in-flight judgments are often gained only through experience—which comes at a high price in too many cases. The Army and Air Force versions of the H-21 tandem rotor helicopter (unaugmented), used for a few years in the early stages of the Vietnam conflict, always acted as though it wanted to swap ends. Accordingly, the pilot workload in the yaw axis was very high.

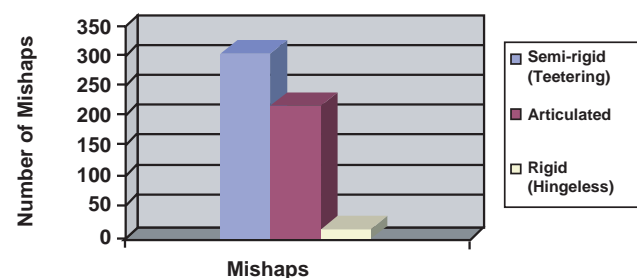
In a significant number of the accidents reviewed, the helicopter's design incorporated a teetering rotor system. Of 547 accidents, 308 (or 56%) of the helicopters had teetering rotor systems (fig. 4). The numbers may, on the face of the data, be misleading. Teetering rotor systems are incorporated in helicopters that have been produced in large numbers for many years. Two manufacturers today are very successful in supplying this teetering rotor system design to the world market. One series of helicopters is relatively inexpensive (approximately \$175,000 and up), powered by a piston engine, and is frequently utilized in pilot training. However, flight training by its nature accounts for a disproportionate number of mishaps. By contrast, the rigid or hingeless rotor systems tend to be incorporated in more sophisticated aircraft, employed in specific missions such as medical transport, and flown by more experienced pilots.

Figure 4. Mishaps by Type of Rotor System.
